Interim Report

Monitoring and Evaluation of Thin Bonded Overlays and Surface Laminates for Bridge Decks

Dave Johnson

August 1997

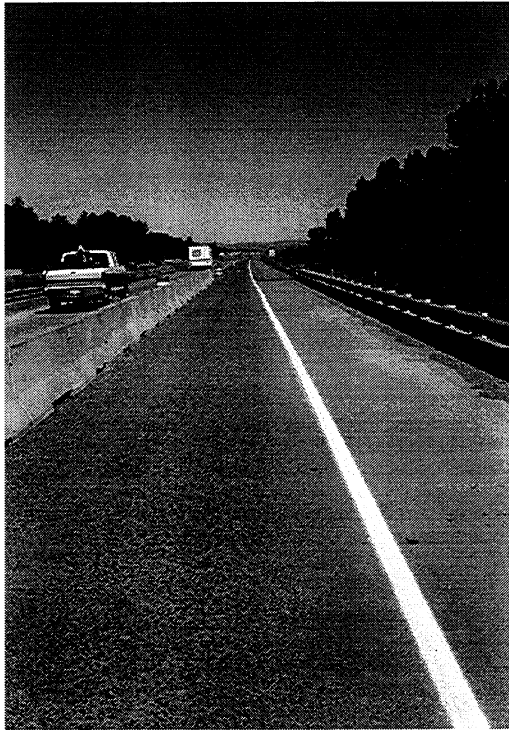
Photo 1: Pre-installation, westbound Gallatin.

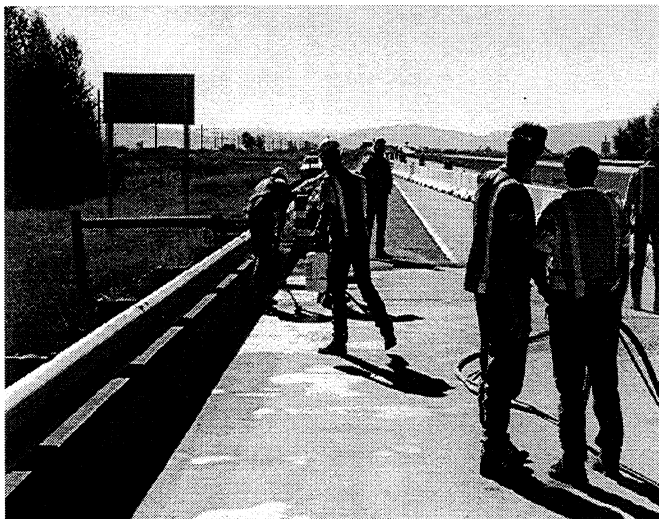
The Thorotop HCR material, consisting of the liquid Thoro polymer and Thoro HCR powder, was mixed on-site in continuous batches. These materials were typically mixed for approximately 5 minutes, sprayed onto the deck, and spread with squeegees (see Figure 3.1.1, Photo 3). Thorotop is placed in two lifts, with the first lift placed on a moist surface. A broom finish was applied to the first lift to promote bonding between the first and second lift. Note that the Thorotop polymer and powder were mixed on the deck, itself, in the area immediately preceding the point of application of the overlay. Polymer was occasionally spilled on the untreated deck during the mixing process as it was dispensed from its storage barrels.

Photo 3: Thorotop HCR installation, Gallatin River.

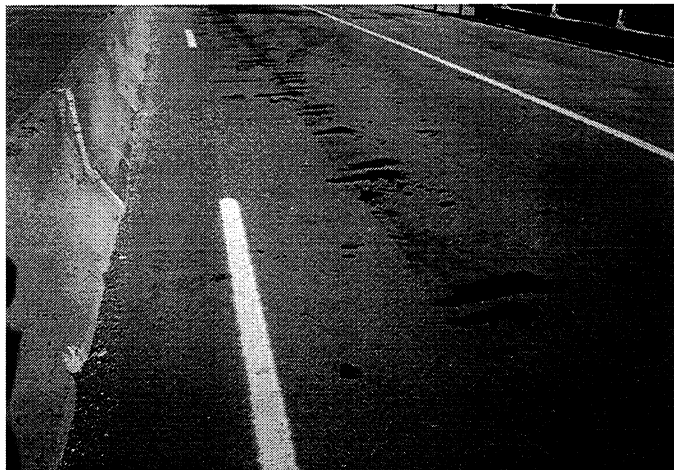
Photo 5: Pre-installation, westbound West Garrison.

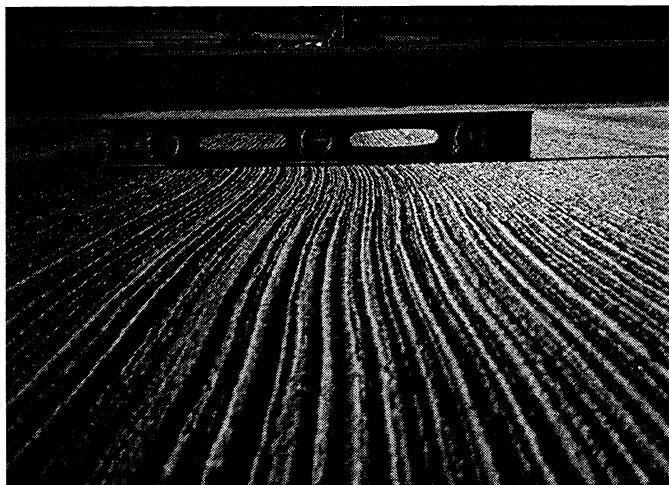
Photo 7: Completed Thorotop HCR overlay, pre-traffic, West Garrison.

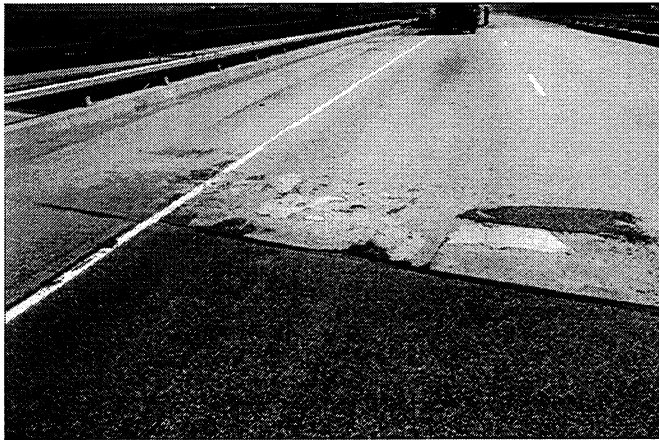
Photo 8: Pre-installation, westbound Galen.

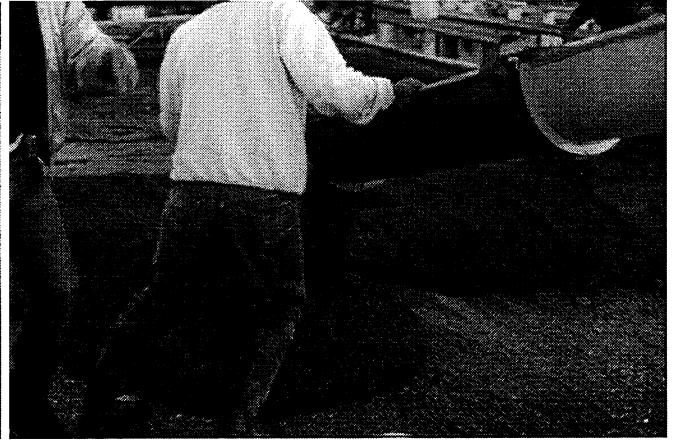
Following the preparation and repair of the decks and curing of repair areas, the overlay process began (see Figure 3.1.3, Photo 9). Application was made in a single lift. Both driving and passing lanes were completed at the same time. A power screed was utilized for the placement. Climatic conditions were measured by the MDT (see Appendix B). Traffic reintroduction occurred after a minimum of 6 days of curing.

Photo 9: Silica fume installation, Galen.

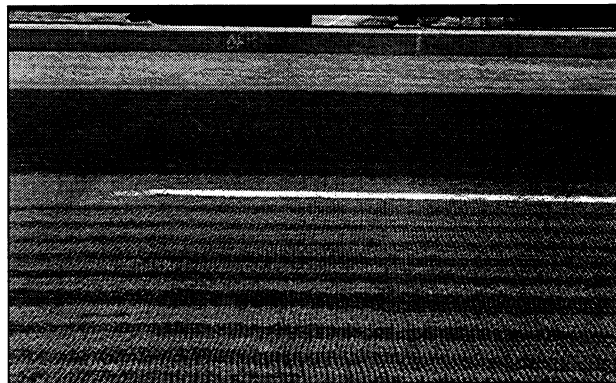
Photo 10: Finished silica fume.

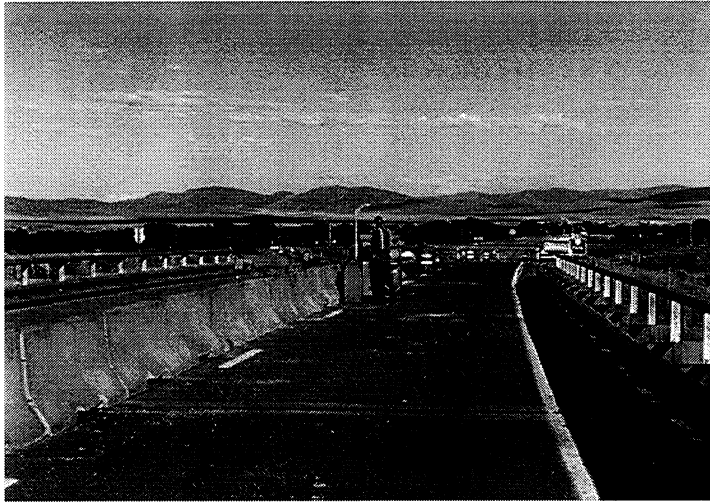
Photo 11: Pre-installation, westbound Madison.
